## EFFECT OF EARTHQUAKE LOAD ON UNREINFORCED BLOCK MASONRY WALLS

Waqas Ali Shah<sup>1</sup>, Khan Shahzada<sup>1</sup>, H. Asfandiyar Ahmed<sup>1</sup>, Fazle Wahab<sup>1</sup>

<sup>1</sup>Department of Civil Engineering, University of Engineering & Technology, Peshawar, Pakistan

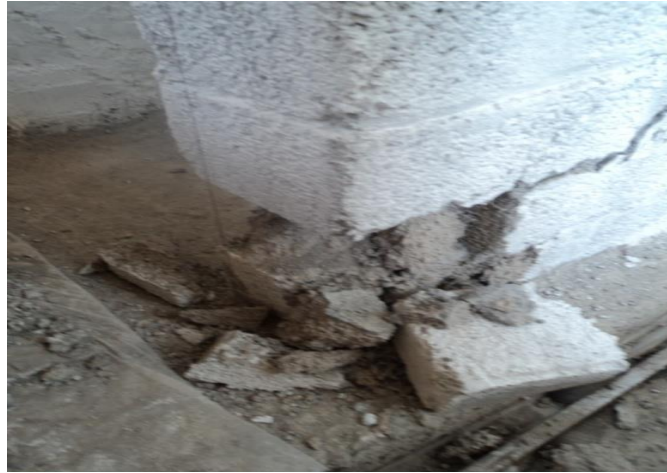
**Figure 5: Crushing of Toe in Unreinforced Masonry Wall at a Story Drift of 0.53% (16 mm displacement)**

- Two blocks were crushed in the pier at 0.4% story drift (12mm displacement) under the lateral load of 12.70 tons.
- Blocks in the toe at 0.53% story drift (16mm displacement) under the lateral load of 13.4 tons were also crushed as show in Figure 5.

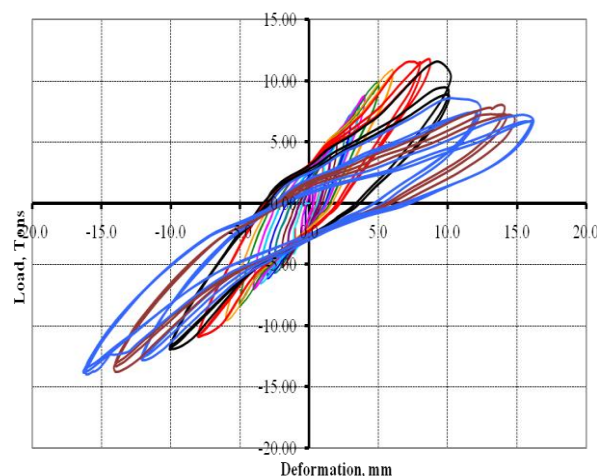
**Figure 6: Hysteresis curve for Unreinforced Block Masonry Wall**

The hysteresis curves were drawn to explain the force deformation behavior for the unreinforced block masonry wall which is given in Figure 6 and Figure 7 respectively.

For the sign convention, southward movement of the hydraulic jack was taken positive having positive displacement to the adjacent lateral load. Where as, Northward movement of the hydraulic jack was taken as negative having negative displacement corresponding to adjacent lateral load.

The stiffness of the Unreinforced Block Masonry Wall decreased with the increase in displacements and for a story drift of 0.20% and at 0.25% it was almost zero.

At a Story drift of 0.33% for unreinforced masonry wall and 0.58%, the structures reached to their peak resistance after which the decrease in strength started slowly.

The strength reduced to 5% of the maximum load at a story drift of 0.39%. When the structure had gained suffered excessive cracks, the test was stopped.
